# Manhole Inspection Summary

Manhole # S35UU1011MH

Insp Date: **1/31/07 3:07 PM**

**Location** Address: **326 PADDINGTON RD**

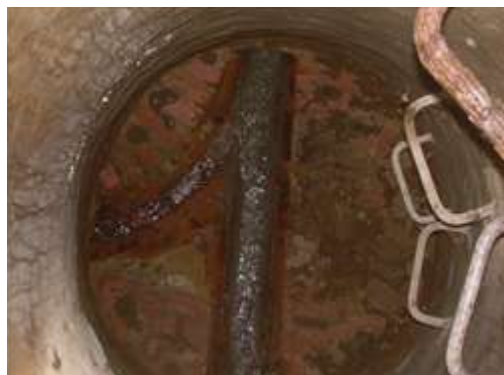
Top View

Corroded steps. Evidence of surcharge - Bench debris.

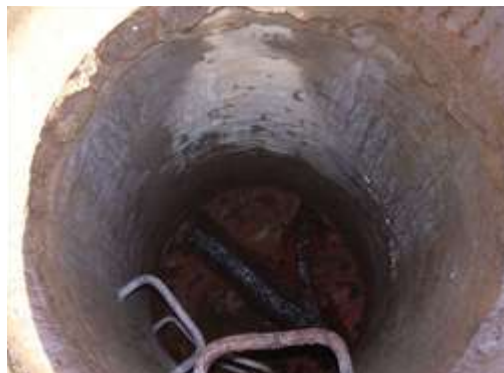
Defect

Adjustment deterioration and infiltration. Corbel and Barrel infiltration - other side.

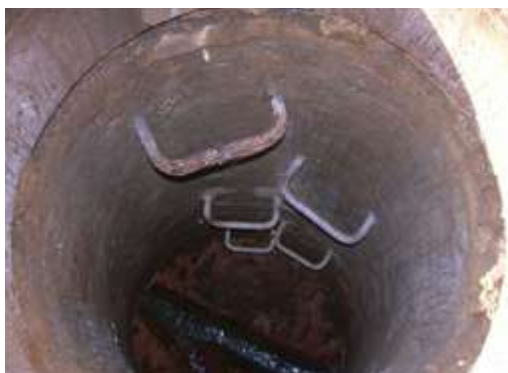
Defect

Adjustment deterioration and infiltration. Corbel and Barrel infiltration.

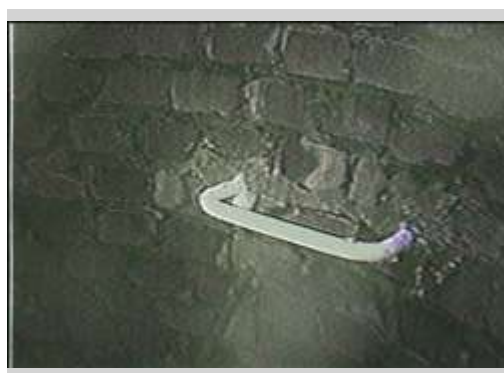
Defect

Barrel deterioration and infiltration.

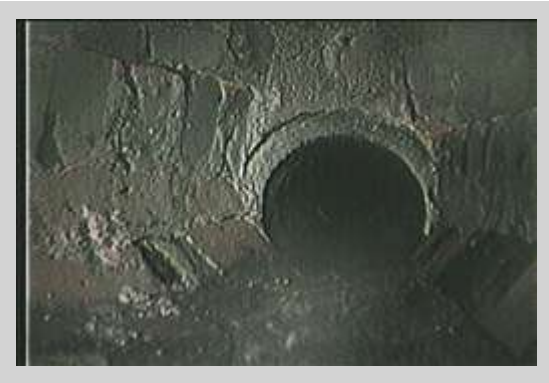
### 8 in. Circular Gravity Sewer Pipe Out @ 12 O'Clock

Infiltration: **Evidence** Pipe Seal Cond: **Unknown**

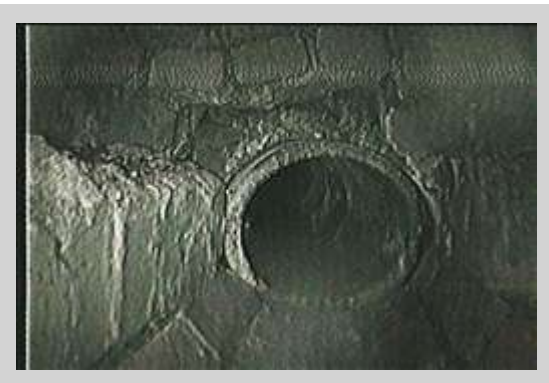
### 8 in. Circular Gravity Sewer Pipe In @ 6 O'Clock

Infiltration: **Evidence** Pipe Seal Cond: **Cracked**
